STRUCTURES  
LABORATORY

WORK UNIT ACCESSION NO		
11 TITLE (Include Security Classification) Condition Survey of Locks and Dam 3, Monongahela River					
12 PERSONAL AUTHOR(S) G. S. Wong, R. L. Stowe					
13a TYPE OF REPORT Final Report		13b TIME COVERED FROM _____ TO _____		14 DATE OF REPORT (Year, Month, Day) August 1988	
				15 PAGE COUNT 33	
16 SUPPLEMENTARY NOTATION Available from National Technical Information Service, 5285 Port Royal Road, Springfield, VA 22161.					
17 COSATI CODES			18 SUBJECT TERMS (Continue on reverse if necessary and identify by block number)		
FIELD	GROUP	SUB-GROUP	Concrete Rehabilitation		
			Condition survey Repair		
			Deterioration rate Service life prediction		
19 ABSTRACT (Continue on reverse if necessary and identify by block number) A condition survey was performed at Locks and Dam No. 3 on the Monongahela River in Pennsylvania to evaluate the concrete condition at the locks and dam, and to make a projection of the concrete condition of selected project features to approximately year 2010. Data from the original construction of the locks, and major rehabilitation of the locks and dam between 1978 and 1980 were evaluated. A visual field investiga

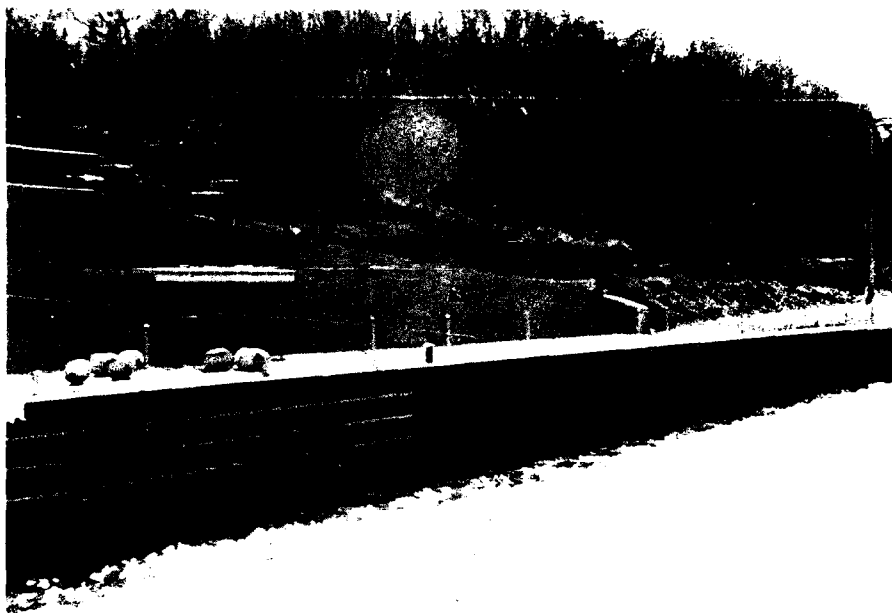
a. Monoliths L-23 to L-18

7. Some of the top surface concrete appeared new while a majority of the surface concrete appeared to be old concrete. The new concrete was in good condition with minor signs of weathering while the old concrete consisted of 60 percent severe scaling and 10 percent very severe scaling. Spalling of concrete was observed in about 20 percent of the monolith joints. A longitudinal crack ran along the top of the guide wall.

8. Vertical surfaces were repaired with shotcrete. The monoliths are armored with the exception of two or three. The shotcrete is severely scaled or spalled in 11 monoliths. The remaining monoliths have medium to light scaling. Small spalls exist in all monolith joints with a high concentration 2-3 ft\* above the water level.

Figure 1. Upper guide wall (continued)

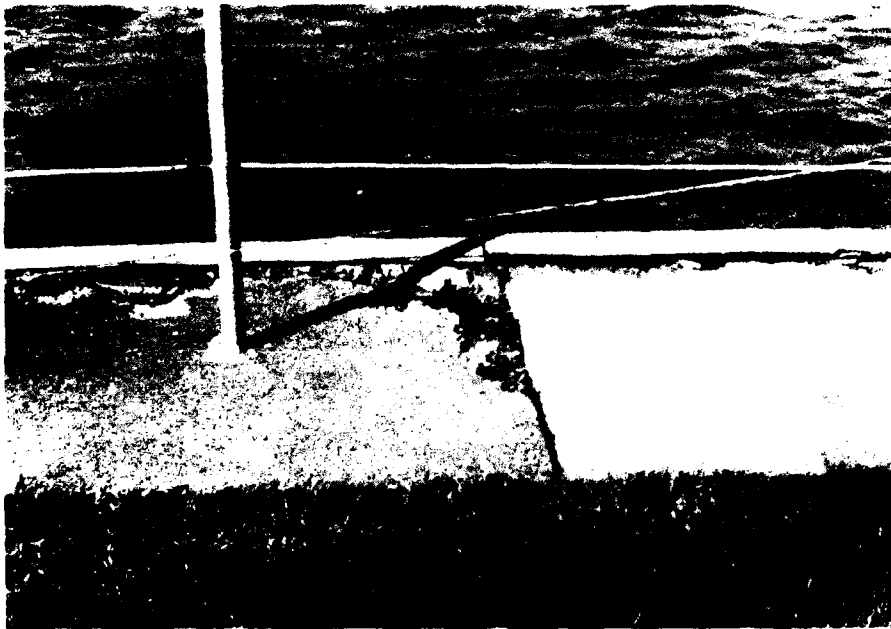
c. Typical top surface

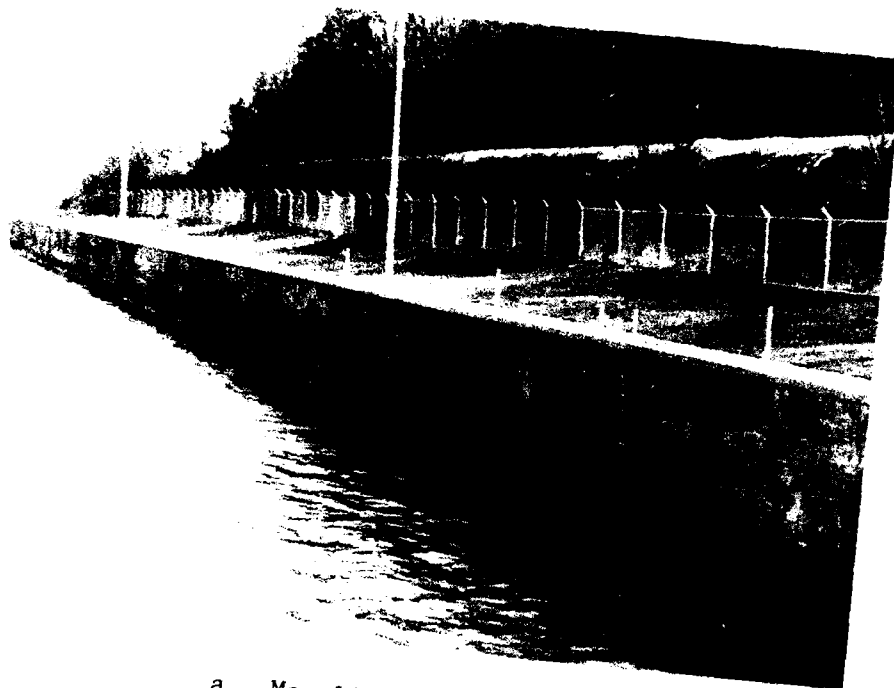
a. Monoliths 48 to L-62

13. Some small spalls had developed at all monolith joints in the lower guide wall. The disaggregation of the shotcrete was most severe at or near the lower pool elevation. Peeling and delamination of shotcrete were evident where the shotcrete was applied to a thickness of less than 1 in.

14. Scaling of the surface was evident with 30 percent very severely scaled, 50 percent severely scaled and 20 percent moderately scaled. A few diagonal and vertical cracks were observed. Cracking was generally infrequent and did not tend to be open. Some shotcrete was spalled due to barge impact, but this spalling was localized.

Figure 3. Lower guide wall

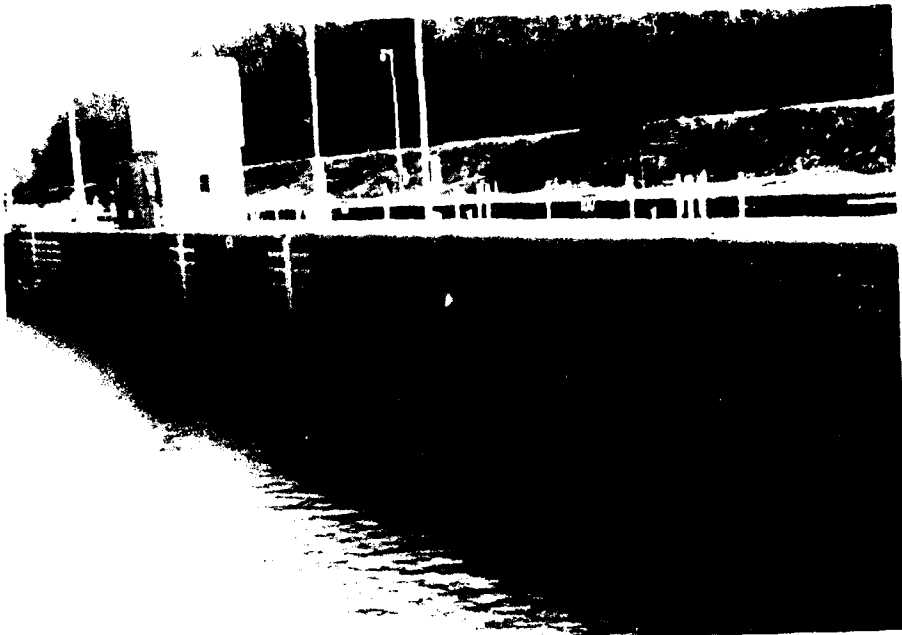
a. Monoliths M-10 to M-14

20. The river face of the middle wall in the river chamber showed light to medium scaling. An estimated 60 percent of the wall had light scaling and approximately 40 percent had medium scaling. Small spalls were present at monolith joints with few horizontal and vertical cracks on the vertical face. There were several large areas where exposed reinforcing steel was observed. These areas were approximately 1 ft deep or more and probably were honeycombed areas developed during refacing of the wall. The top 18 in. of the surface concrete had vertical cracks with efflorescence. It also contained some fine horizontal cracks with efflorescence.

Figure 7. Middle wall river face

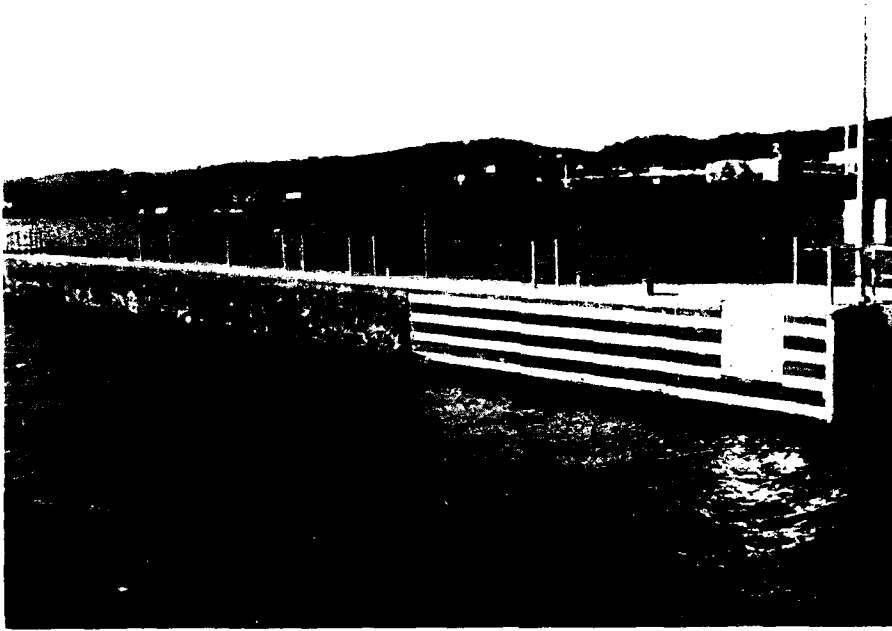
a. Monoliths R-1 to R-11

23. The land face was resurfaced using shotcrete application. Forty percent of the shotcrete showed signs of delamination exposing some reinforcing steel. Sixty percent of the surface had medium scaling. Original concrete is exposed in several areas at the upper pool elevation. The shotcrete that was placed during the 1978-1980 rehabilitation work has dropped off the wall in these areas; thickness of missing shotcrete is 3 in. Large spalls were observed at the ends of the guard wall where barges had impacted the wall.

Figure 8. Concrete in the upper guard wall land face (continued)

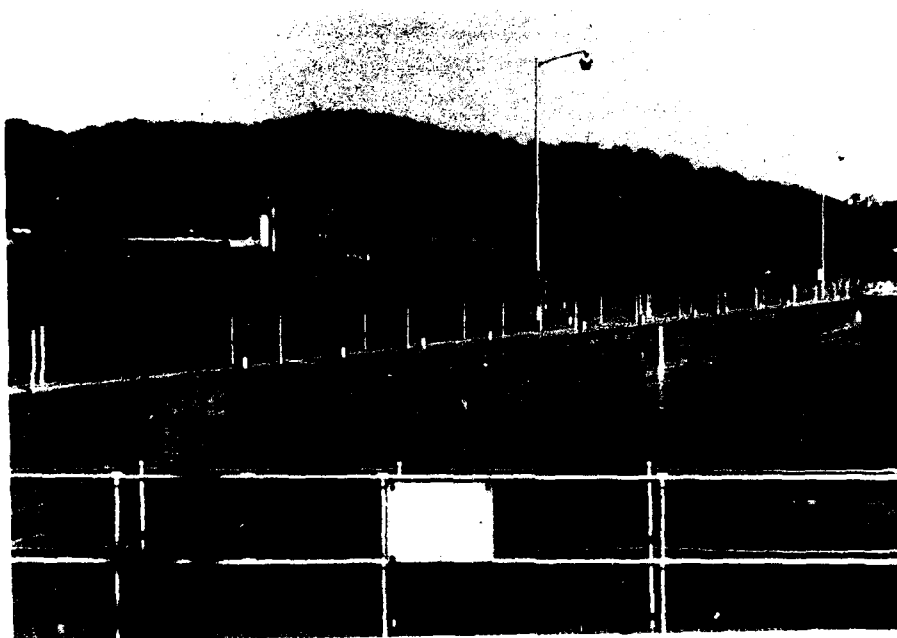
Figure 9. River wall lock chamber

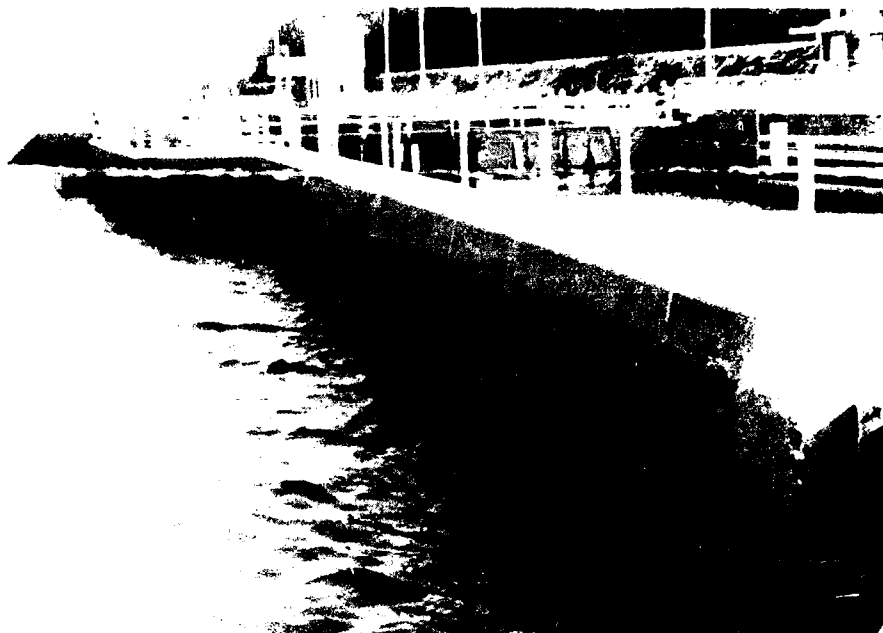
a. Monoliths R-12 to R-7

28. The river wall river face was repaired using shotcrete from the top of the wall to the water level. A work flat was tied to the wall near the upper gate and a closer look was taken at the repair near the upper pool elevation. Some 3-ft deep voids that were not repaired were observed. The shotcrete was scaled to 0.5- to 0.75-in. depth. Some reinforcement and mesh were exposed.

Figure 10. River face, river wall
